REPORT ON THE
THERMAL SURVEY
OF THE ELECTRICAL
FACILITIES AT:
SAMPLE SITE
SMITH ST, BANKSTOWN NSW

Prepared for
JOHN SMITH of
ABC PTY LTD
by AARON JENKINS
15TH JANUARY 2023

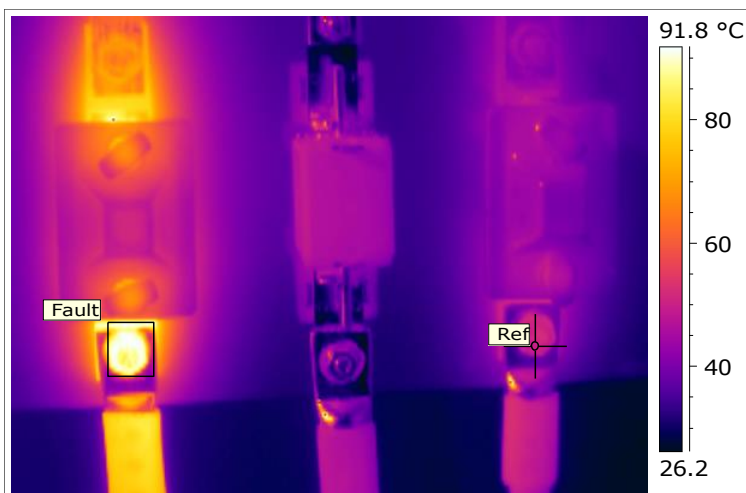
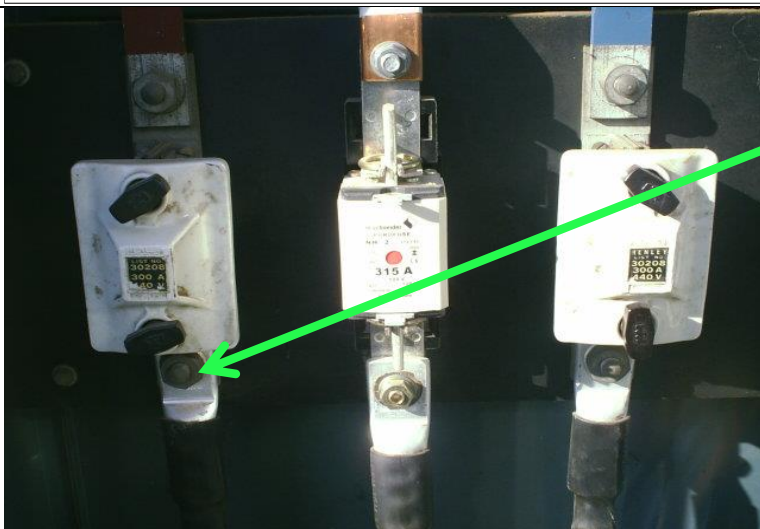
1

LOCATION	Outside tenant M16
SWITCHBOARD	Link panel
COMPONENT	Service fuse
OBSERVATION	Red phase lower connection

Ref Temperature	50.0°C
Fault Max. temperature	92.3°C
Temperature difference	42.3°C

Red phase	152	amps
White phase	169	amps
Blue phase	162	amps

Check crimp on cable lug, clean and re-tension connection

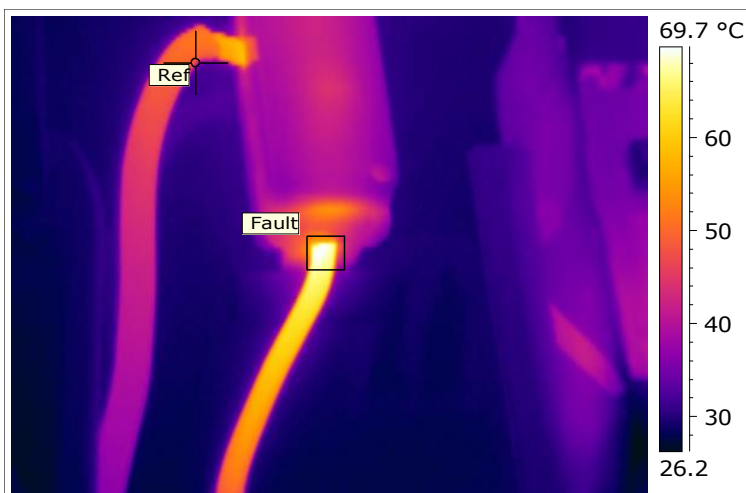
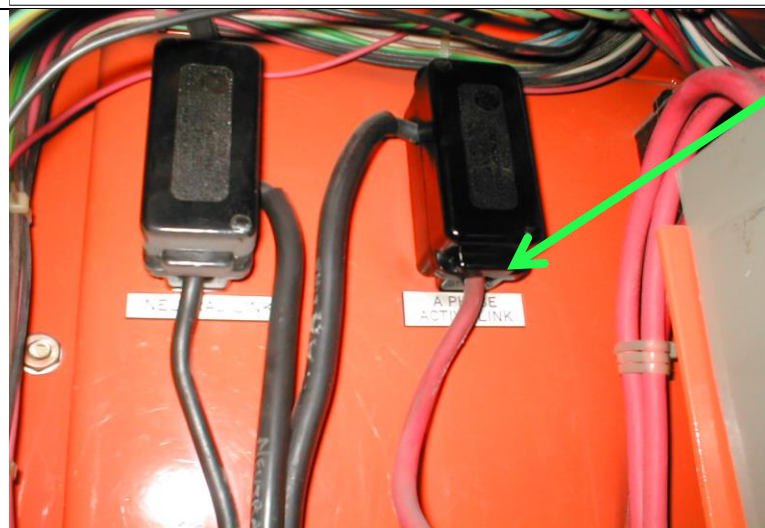
2

LOCATION	Main Switch Room
SWITCHBOARD	Distribution Board R
COMPONENT	Active link
OBSERVATION	Red phase load side

Load side Maximum	25.3 °C
Fault Max. temperature	70.3°C
Temperature difference	23.8°C

Red phase	53 amps
-----------	---------

Check, clean and re-tension connection.

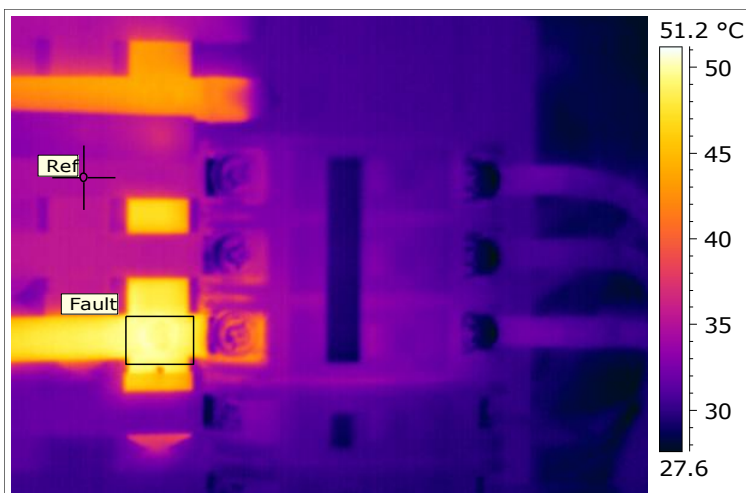
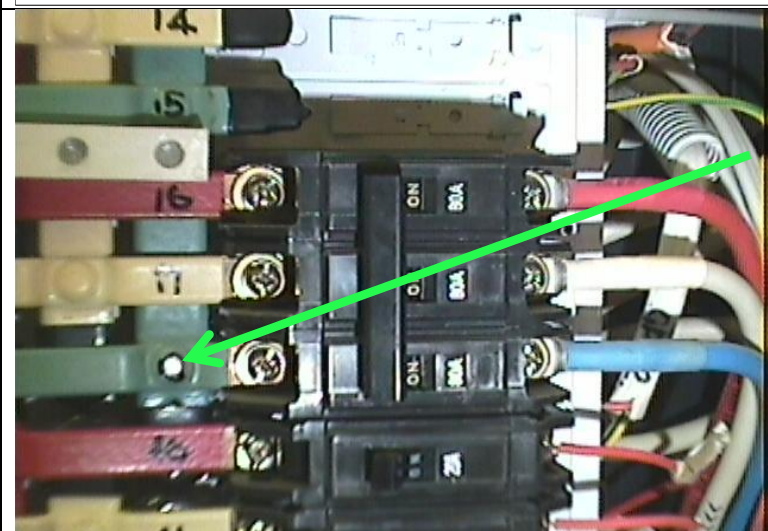
3

LOCATION	Level 1
SWITCHBOARD	Distribution Board H1
COMPONENT	Circuit breaker 17 (submain switch 19-60)
OBSERVATION	Busbar rivet

Ref Temperature	35.0 °C
Fault Max. Temperature	50.5 °C
Temperature Diff.	15.5 °C

Red phase	13.8 amps
White phase	6.3 amps
Blue phase	27.8 amps

Investigate fault, repair or replace as required.

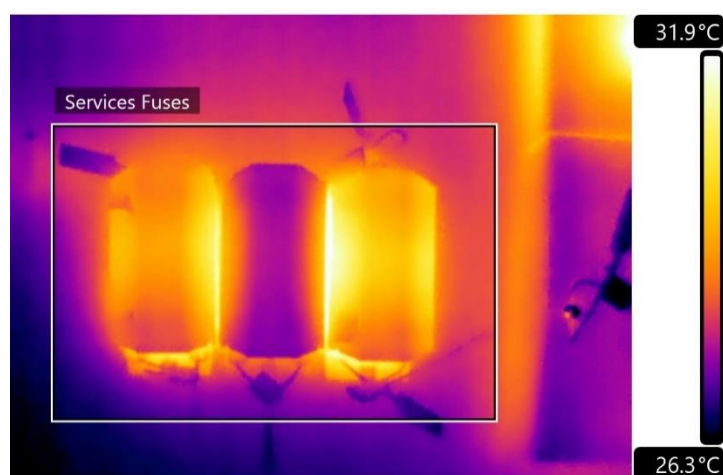
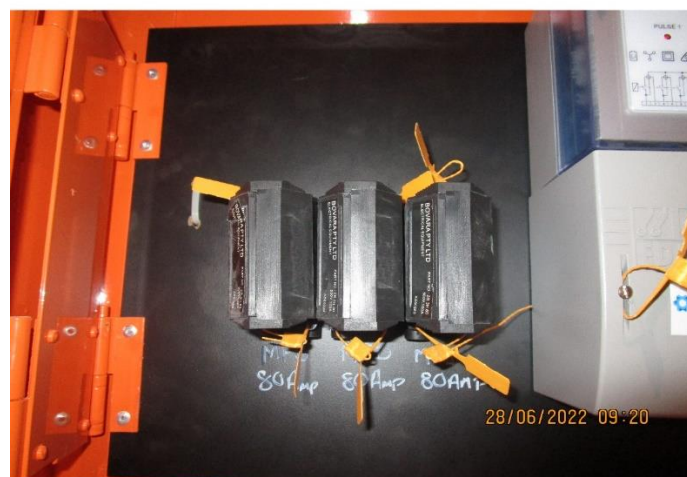
4

LOCATION	Plant Room
SWITCHBOARD	Fuse link box
COMPONENT	Fuses
OBSERVATION	No abnormal thermal activity detected

Service Fuses Maximum	33.1 °C
--------------------------	---------

The temperatures recorded in the Results Table above are considered to be normal operating temperature and no further action will be necessary.
